FLYERS ASSOCIATION NEWS

NUMBER 02-2

AUGUST 2002

SUBJECT: PNEUMATIC MANIFOLD CHECK VALVE FUNCTIONAL TEST

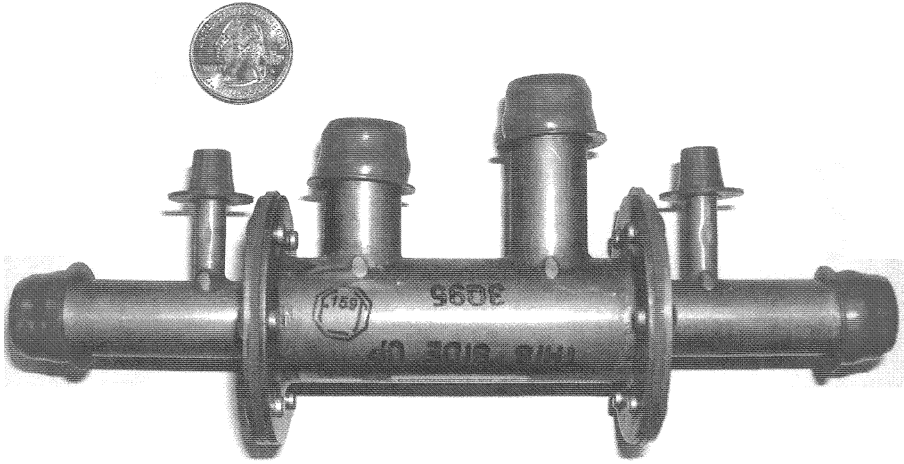
NEW CHECK VALVE

As reported in Newsletter 02-1 Raytheon have a new instrument air check valve, Part HE7007-5 which cost less than ½ of the older model - \$648.00. The Organization has 2 of these on hand at DFA price of \$595.00. At this price is might be a good idea to install a new one at your next annual. Remember: Dukes are between 33 and 19 years old. For more information see Newsletter 01-2, Pages 4 and 5 and Raytheon Safety Communique enclosed.
