DFA NEWSLETTER

DUKE FLYERS ASSOCIATION, LLC

Welcome to the second quarter newsletter.

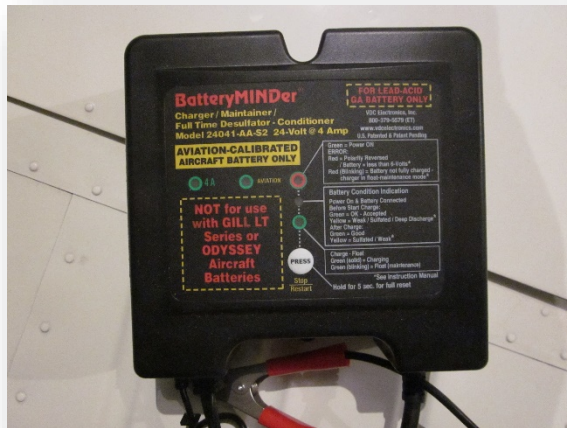
Some owners may not know of the simple way to keep our 24-volt battery fully charged. Plugging in an external source at the external power receptacle does not connect to the battery. One option is to remove the left engine nacelle cover to connect directly to the battery. A better way, and it should only take a few minutes for the mod, is to locate the hot wire leading to the front baggage compartment dome-light. Be careful, this wire is always hot! Splice on a short length of wire to the light fixture hot terminal. If you want to get fancy, crimp on a 2-wire female connector. Change the fuse in the left engine rear nacelle from 5 amps to 10 amps. It's hidden high up the front bulkhead under the right-hand relay. If you know nothing about electrical circuits, ask your tech to do this. Now connect a 24-volt, aircraft battery tending device (such as the Battery Minder) and you are set.

Keep your battery fully charged

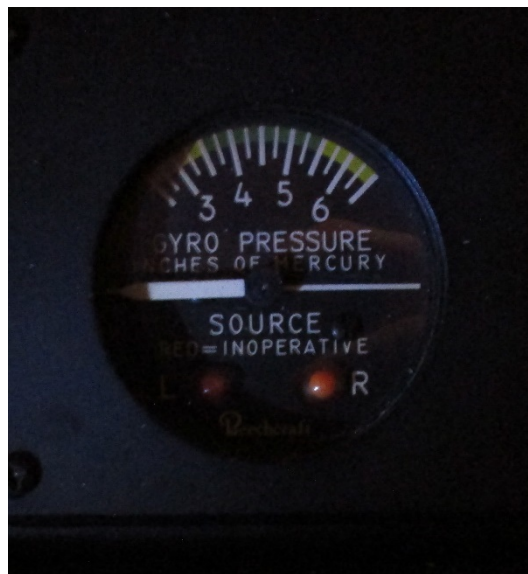
1. Start the left engine in accordance with the POH. After start, confirm that the left red ball in the instrument air source gauge is out of view and that the right red ball remains.
2. Start the right engine in accordance with the POH. After start, confirm that both the left and right red balls in the instrument air source gauge are out of view.

1. Shut down the left engine in accordance with the POH. After shutdown, confirm that the left red ball in the instrument air source gauge is in view and that the right red ball is out of view.
2. Shut down the right engine in accordance with the POH. After shutdown, confirm that both the left and right red balls in the instrument source gauge are in view.

Adherence to this procedure will ensure that from the prior shutdown to the next start-up, both sides of the manifold check valve will be functionally checked without putting the strain of additional start cycles on the engine and starting system.

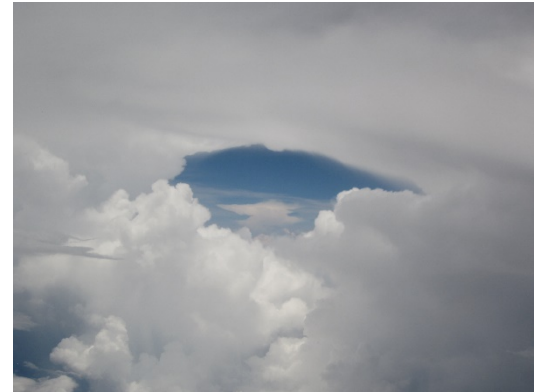
Give yourself a minimum of forty miles between two cells

The FAA and NTSB were very supportive and after the teleconference debriefing with the NTSB and Southern Florida ATC. Although it had been my decision, the NTSB felt that the controller should have warned us that we were entering a level 6 echo. If I had been aware of the severity of the conditions within the cell, I would have opted for landing in Norfolk to fuel. This incident/accident was a result of something for which I swore I would never fall prey. The simple rule of waiting a few hours or even overnight, if conditions don't look or feel right, can make all the difference for a flight. Lessoned re- learned--- Now I wait! (Editor's note: civilian, military and part 121 consensus is 20 miles minimum spacing from a cell—on the upwind side. Therefore, spacing between two cells should be a minimum of 40nm.)

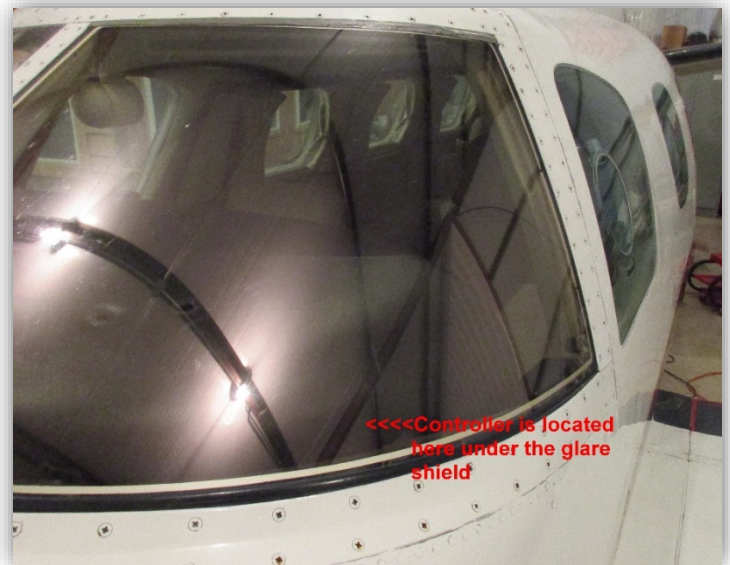
The part from the previous newsletter was a windshield heat **controller**. It is located under the glare shield, front left side, attached to the pressure bulkhead. It is one of two components that typically cause the windshield heat to fail. The other typical failure point is the windshield heat **inverter** which is located near the aircraft battery.
